Assessment of Dam Safety

Coal Combustion Surface Impoundments (Task 3)

American Electric Power

Conesville
Generating Station

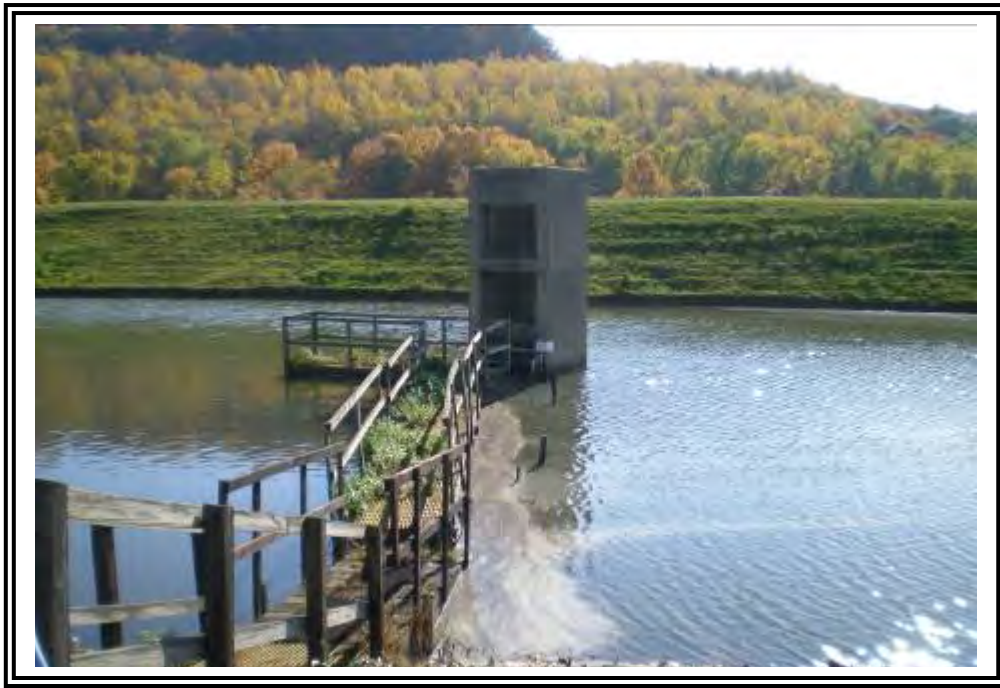
33

The Clearwater Pond outfall structure.

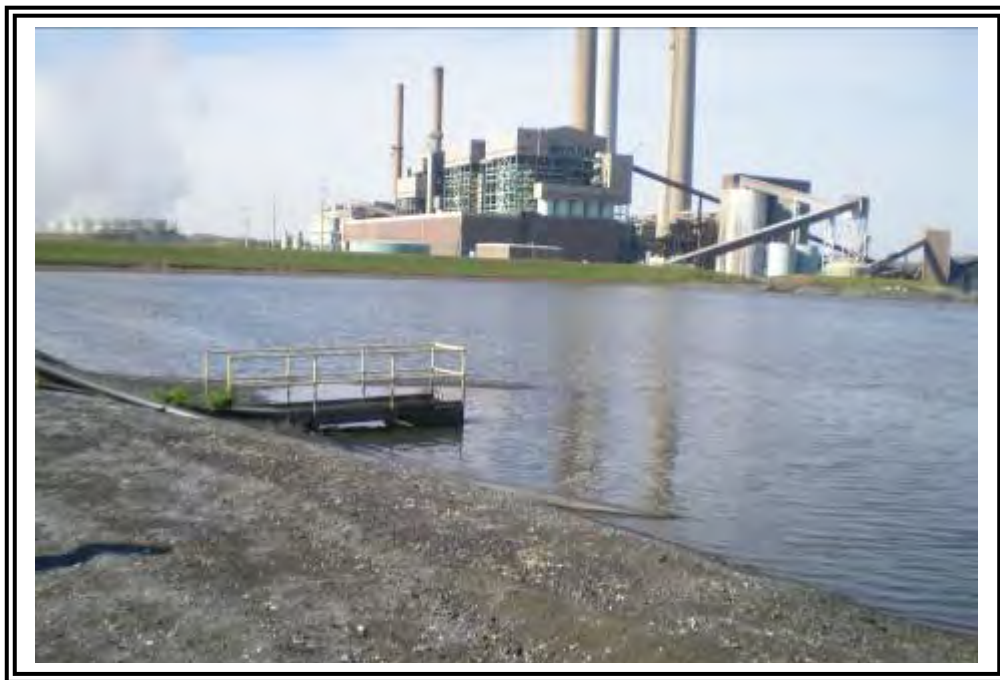
34

The Bottom Ash Pond outfall structure.

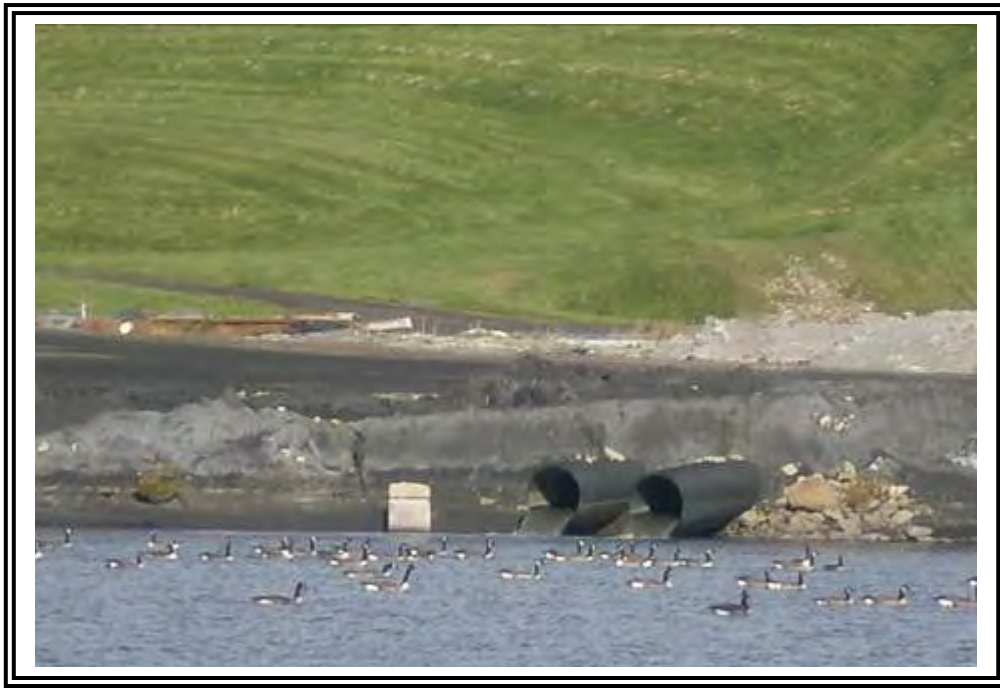
35

Looking across the bottom ash pond at sluice lines into the pond.

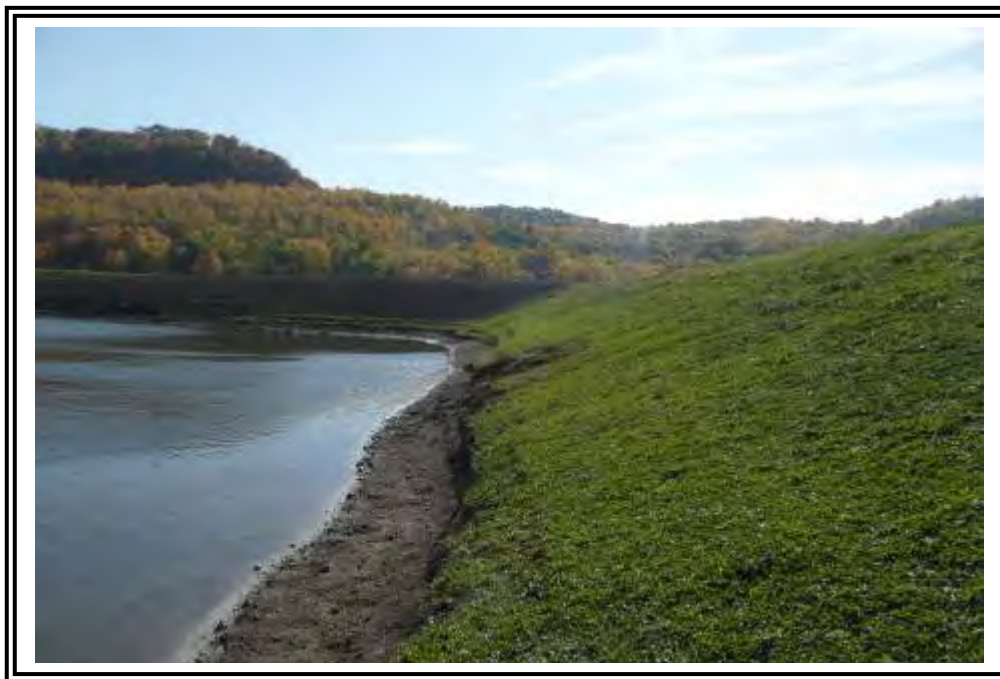
36

Upstream slope at the Clearwater Pond. Notice the beaching along the water line of the slope.

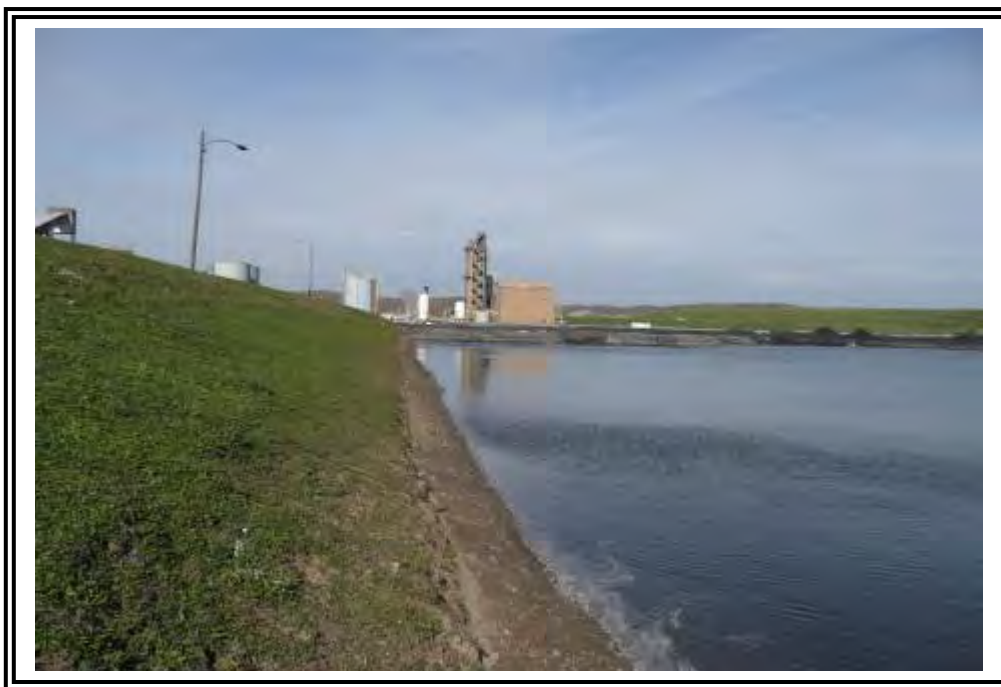
37

Looking northwest along upstream slope of the Southwest Dike along the Bottom Ash Pond.
Notice beaching erosion along the waterline.

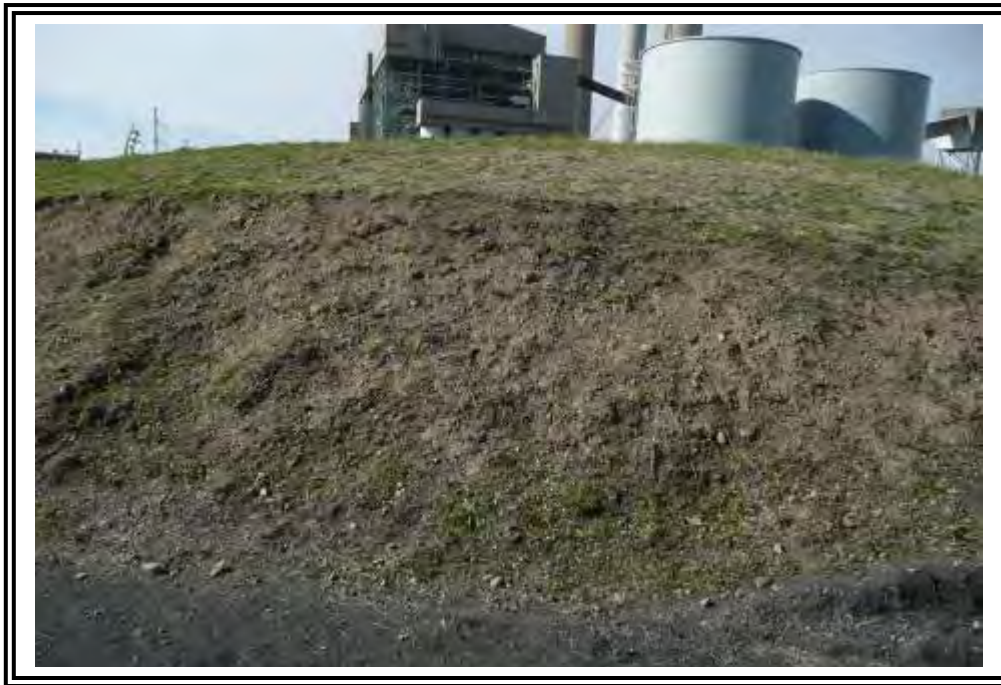
39

Close up of maintenance road cut in Southwest Dike near the plant's water treatment facility.

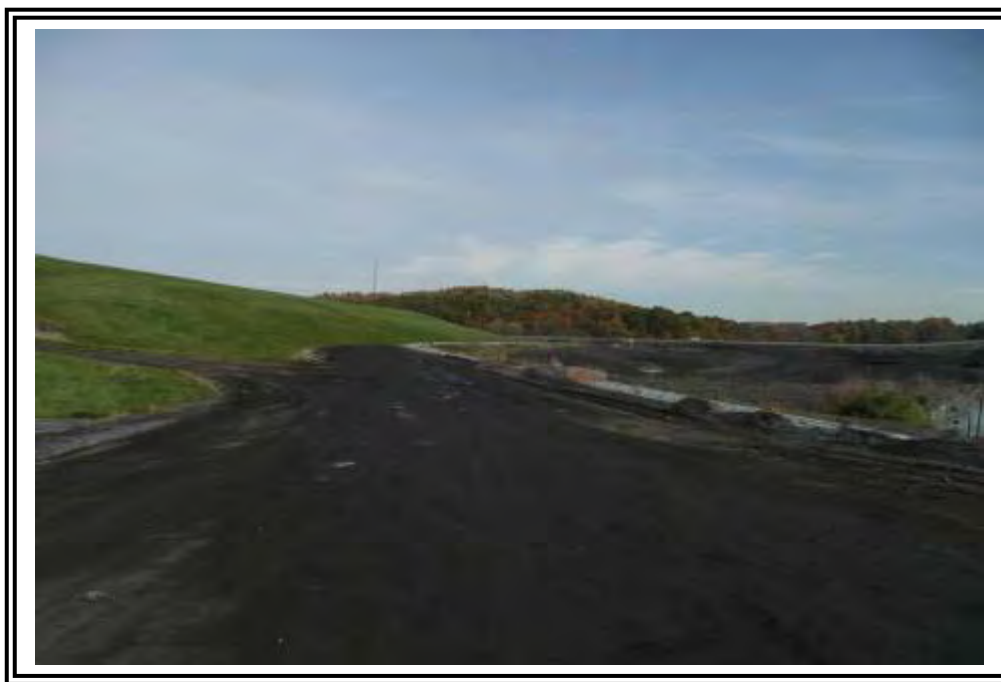
40

Looking northeast from the northwest end of the Southwest Dike along western side of the complex.
The closed FGD area is to the left of the photo.

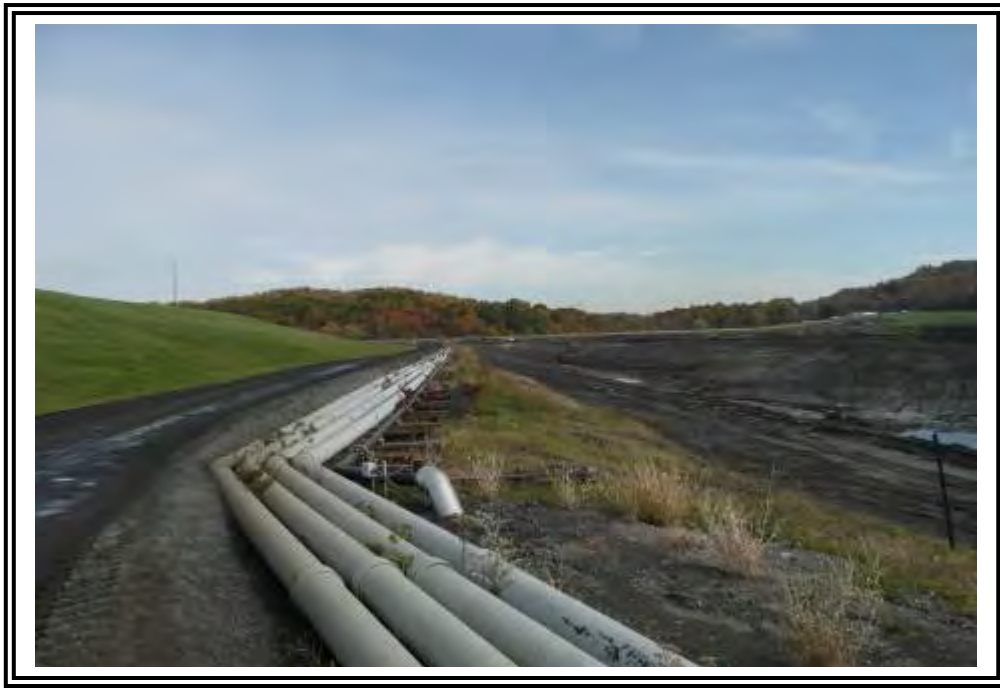
41

Sluice lines running to the Fly Ash Pond along the western side of the complex.

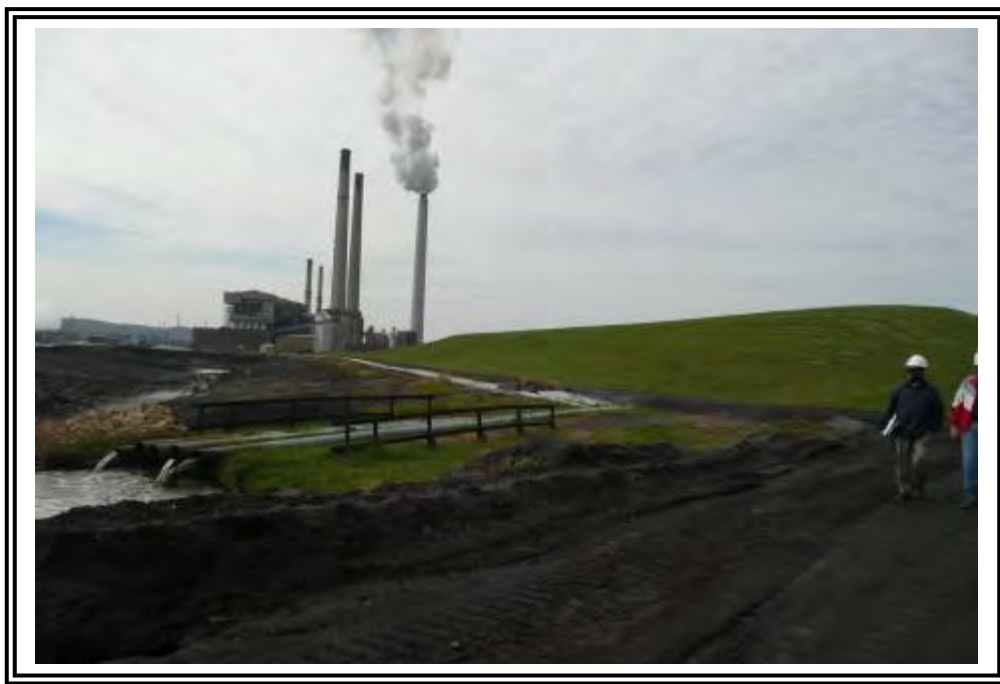
42

Sluice lines running into the Fly Ash Pond.

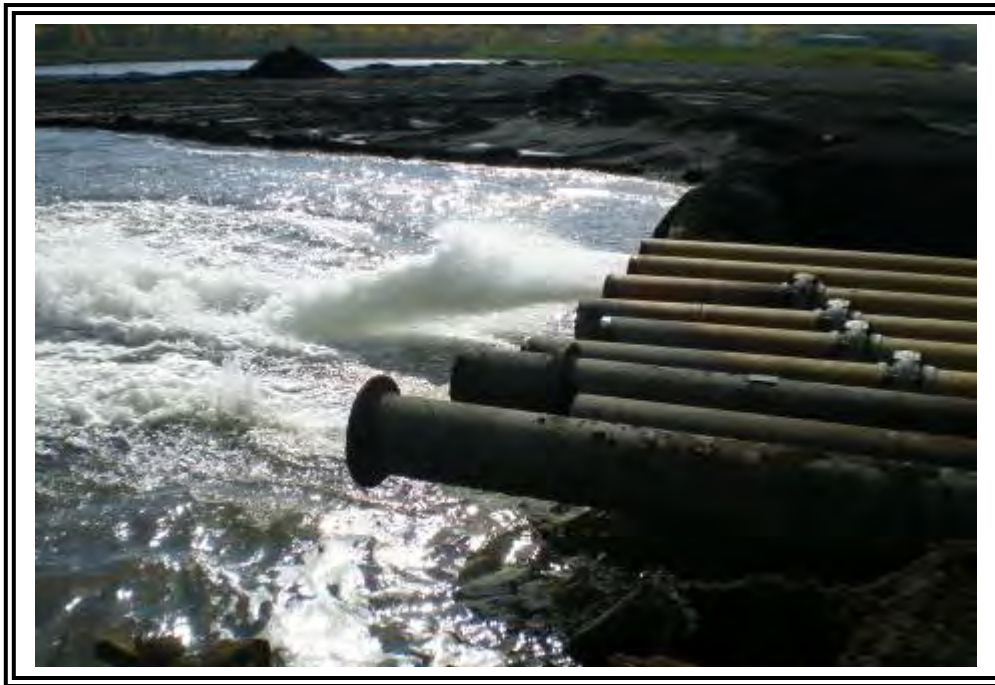
43

Close up of sluice lines running into the Fly Ash Pond.

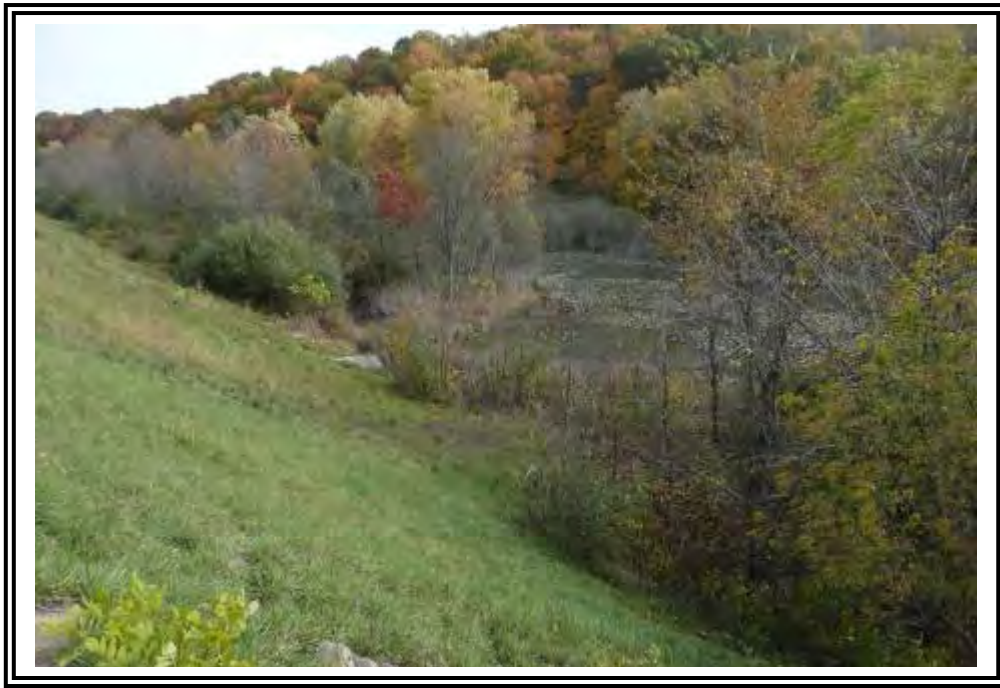
45

Looking northeast along downstream slope of the Coal Haul Road embankment near the Ash Pond Complex outfall.

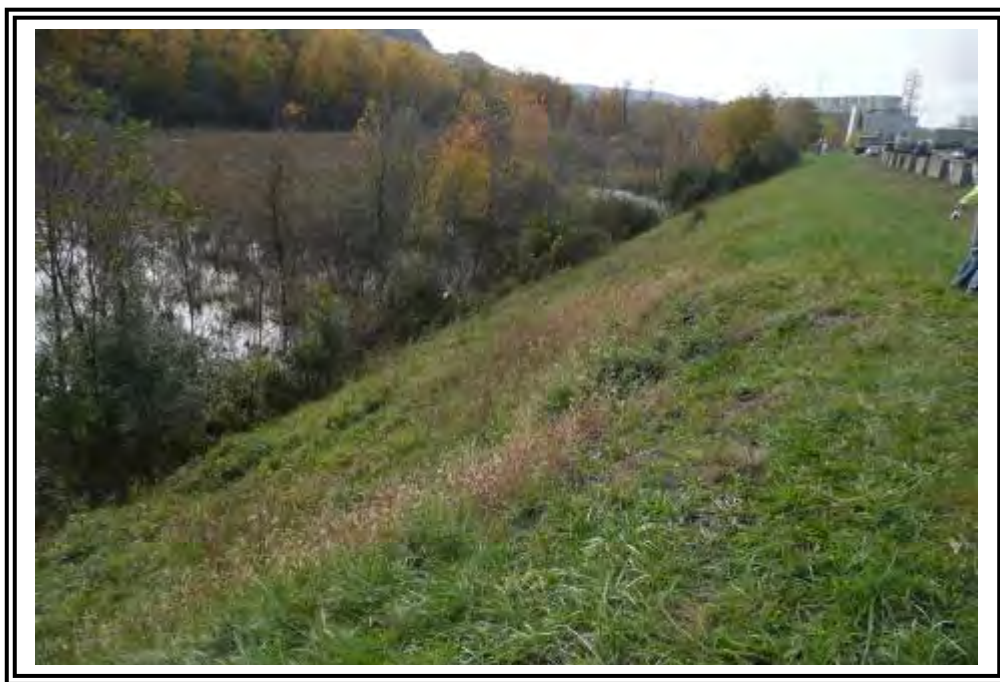
46

Looking southwest along Coal Haul Road embankment.

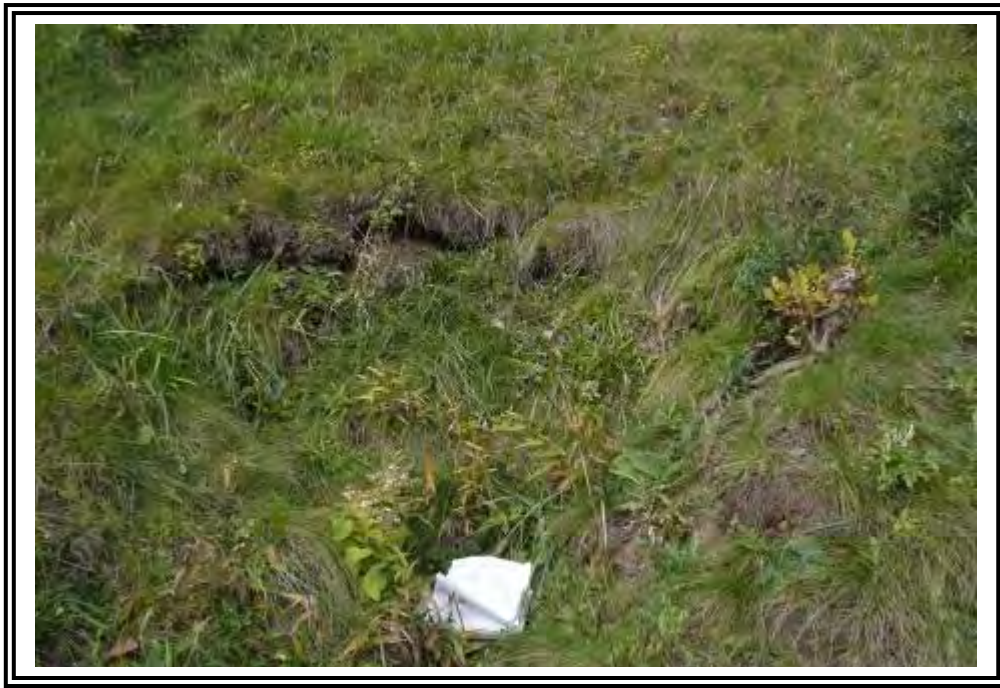
47

Slough in downstream slope of Coal Haul Road Dike.

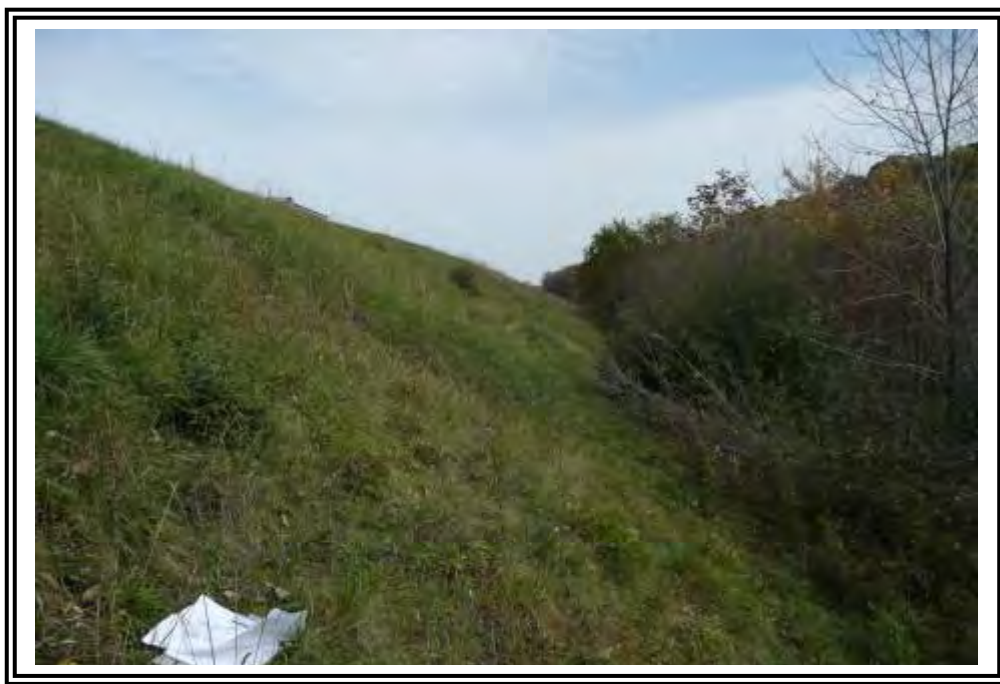
48

Another view of the slough in Coal Haul Road Dike, looking northeast.

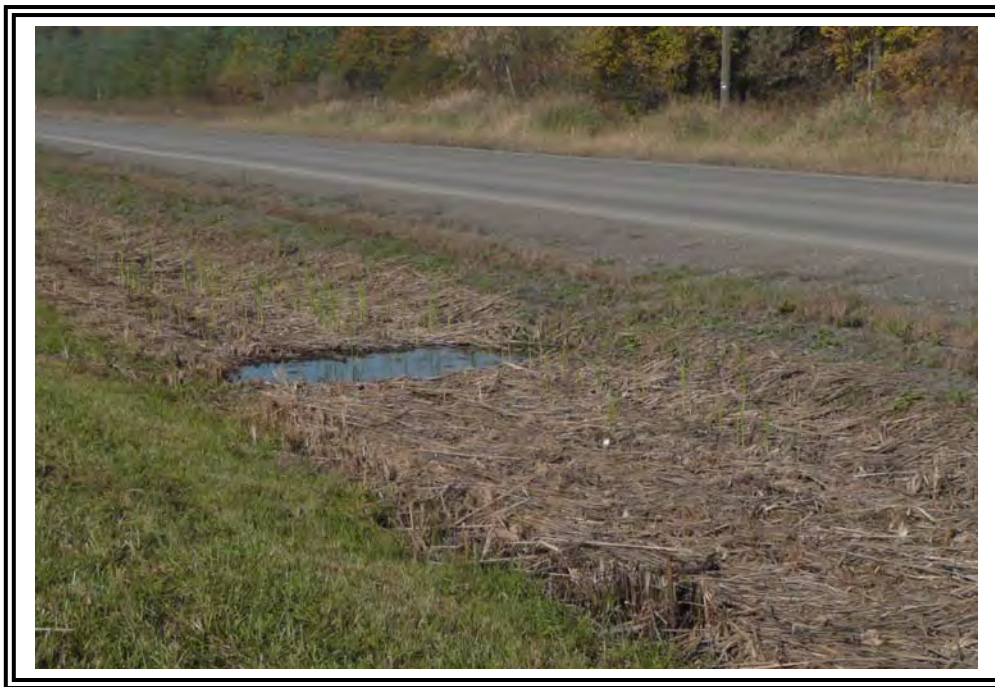
49

Recently mowed cattail growth in drainage swale at toe of the North Haul Road Dike and County Route 273.

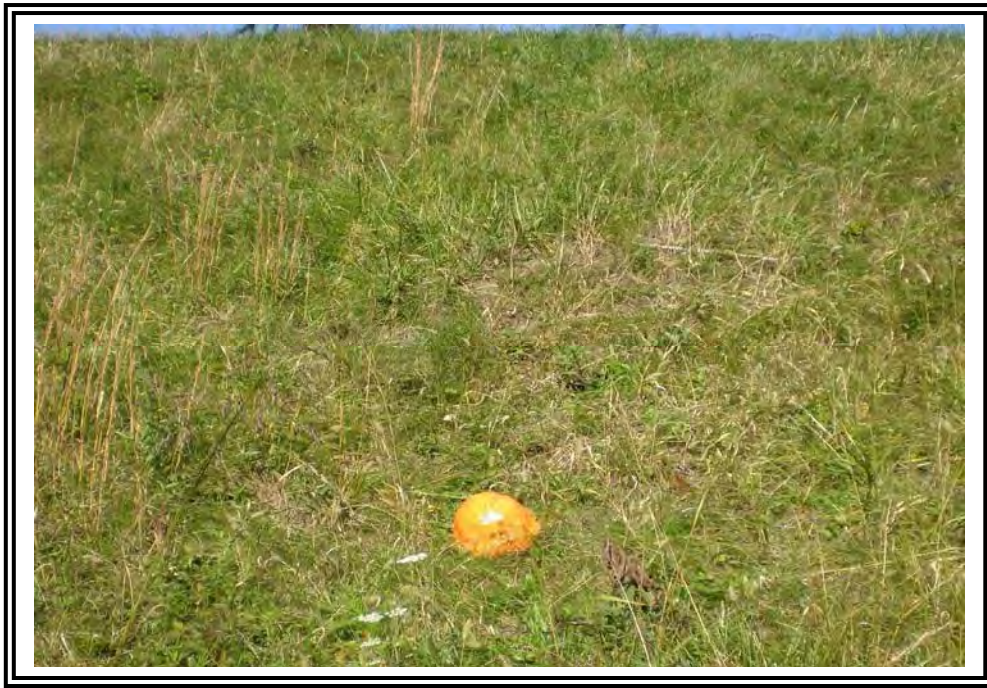
51

Grassed erosion rill on downstream slope of Coal Haul Road Dike. Hard hat is in bottom of rill.

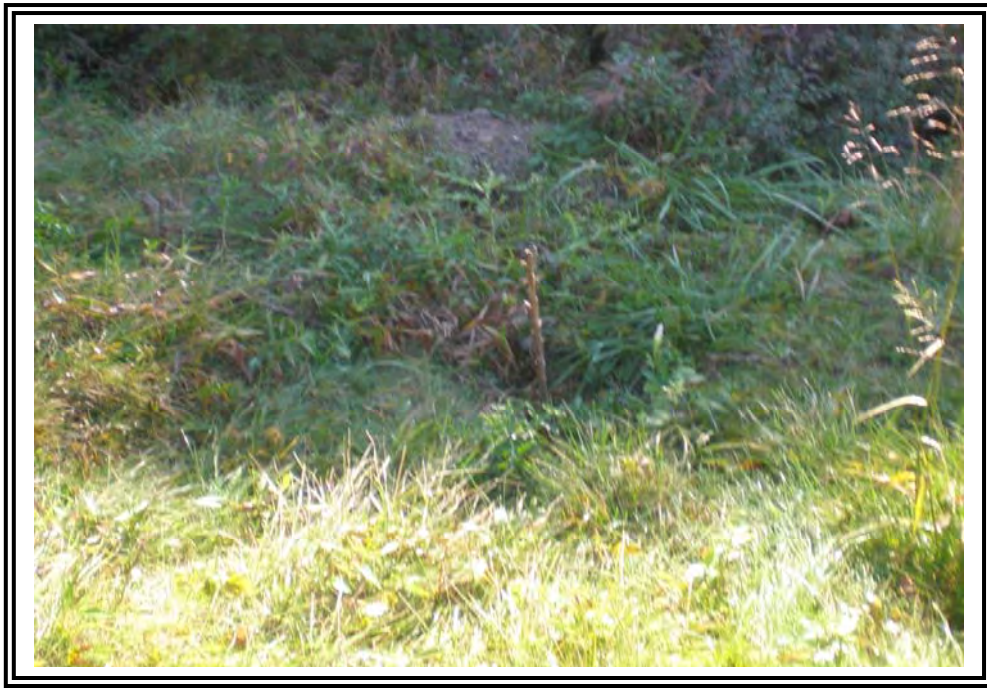
53

Open rodent burrow in area of older collapsed burrows that have become erosion rills (stick is in burrow) in Coal Haul Road Dike.

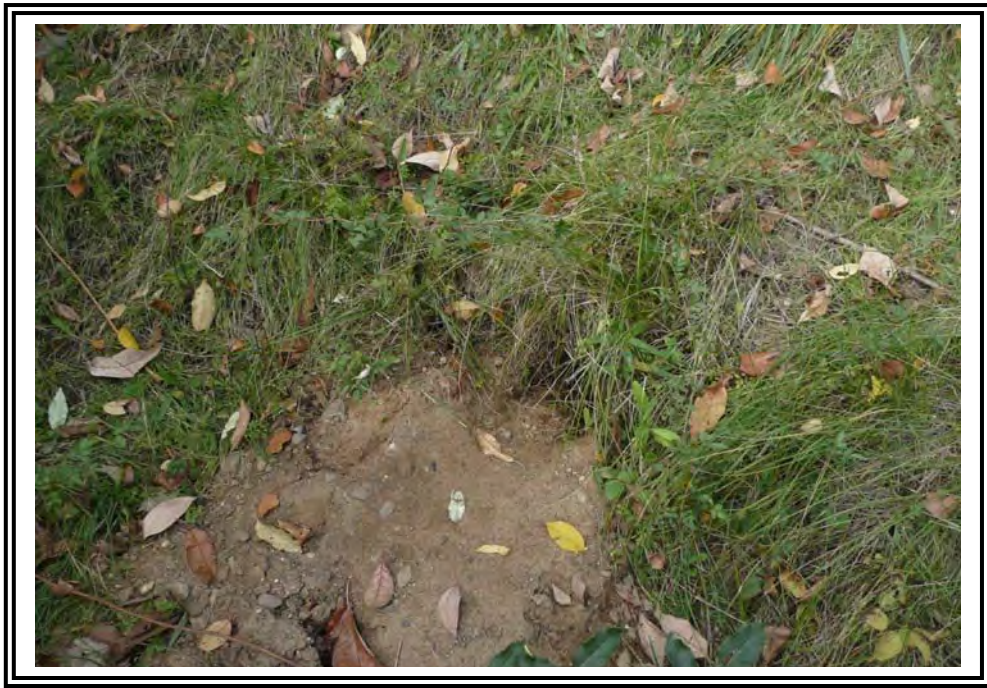
55

More recent rodent burrow in Coal Haul Road Dike with exposed soil spoil.

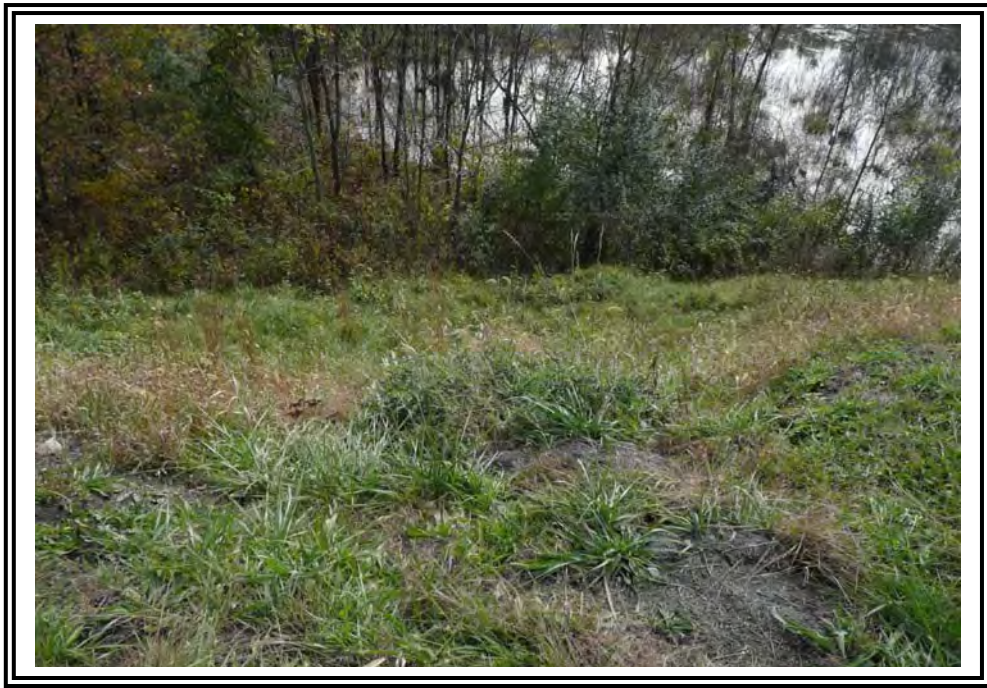
In addition to the erosion features, a scarp with an adjacent depression and slump was also observed on the downstream slope along with older grass covered deformation features likely the result of surficial soil softening, concentrated runoff from the roadway, and dust control efforts. In the case of the latter, finer grained coal dust, soil, and other debris is washed or swept from the road onto the slope and build up over time. These are shown in Photos 47, 48, and 56. Examples of the soil and dust transport from the roadway with subsequent grass cover loss can be seen in Photos 57 and 58.

Example of soil and coal dust transport and intermittent grass cover loss near crest of Coal Haul Road Dike.
